**801 units: Direct-bury versus utilidor-  
enclosed underground utility piping  
systems in the 801-lease areas.**

Information provided by Eielson AFB  
9/14/2010

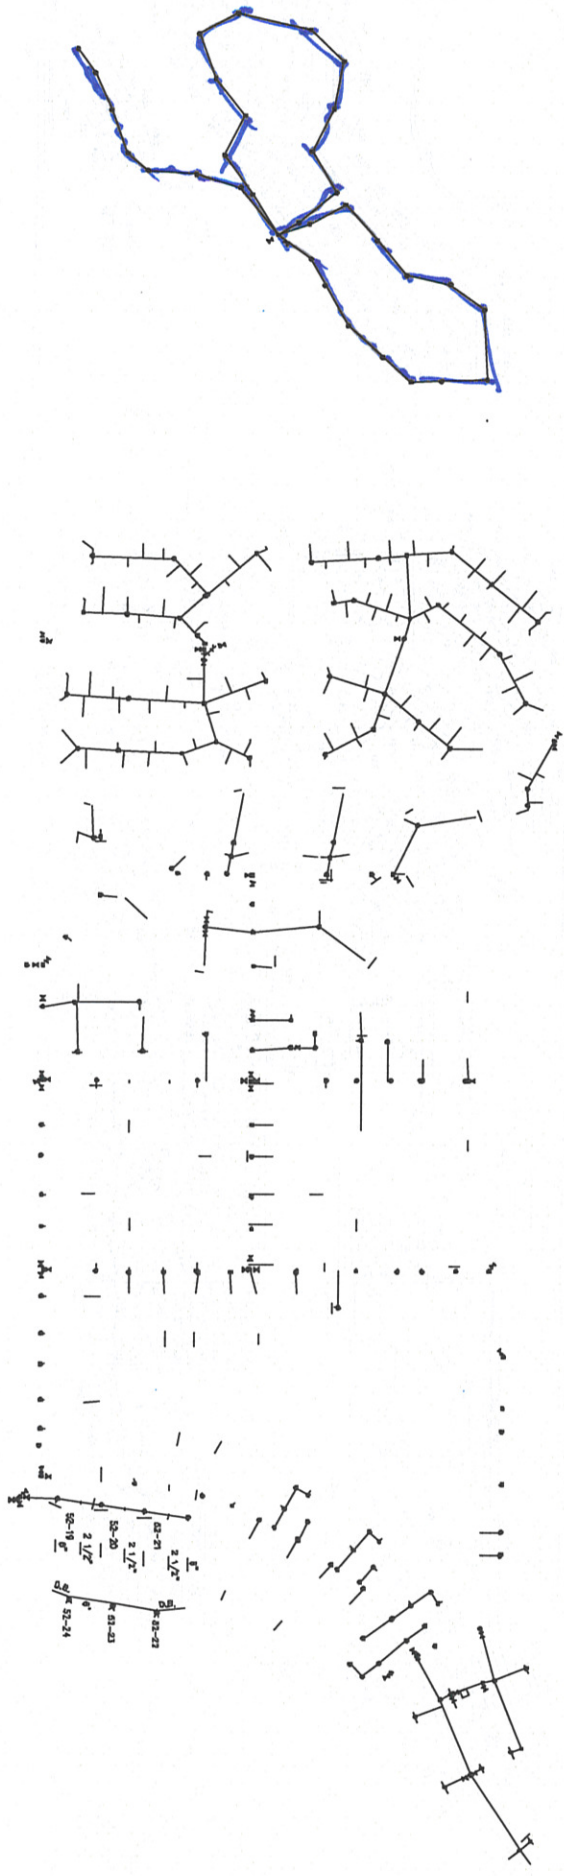
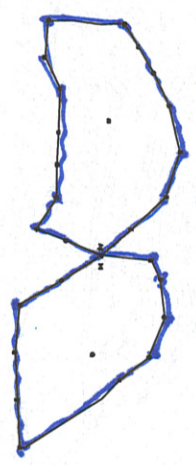
Following page (Blue Color Code): This map provides a single line depiction of the DIRECT-BURY underground utility piping serving the 801-lease areas. The direct bury piping systems include: heat supply & return, drinking water supply & return with fire hydrants located on drinking water supply piping, and wastewater (sewer) collection piping. NOTE: The direct bury piping systems need repairs; either continued repair of increasingly frequent breaks, or a total repair-by-replacement effort. Also, the heat supply/return piping transports heated liquid (water); the heat supply water leaves the primary mechanical buildings at approximately 190 degF & the heat return water comes back to the primary mechanical buildings at approximately 140 degF.

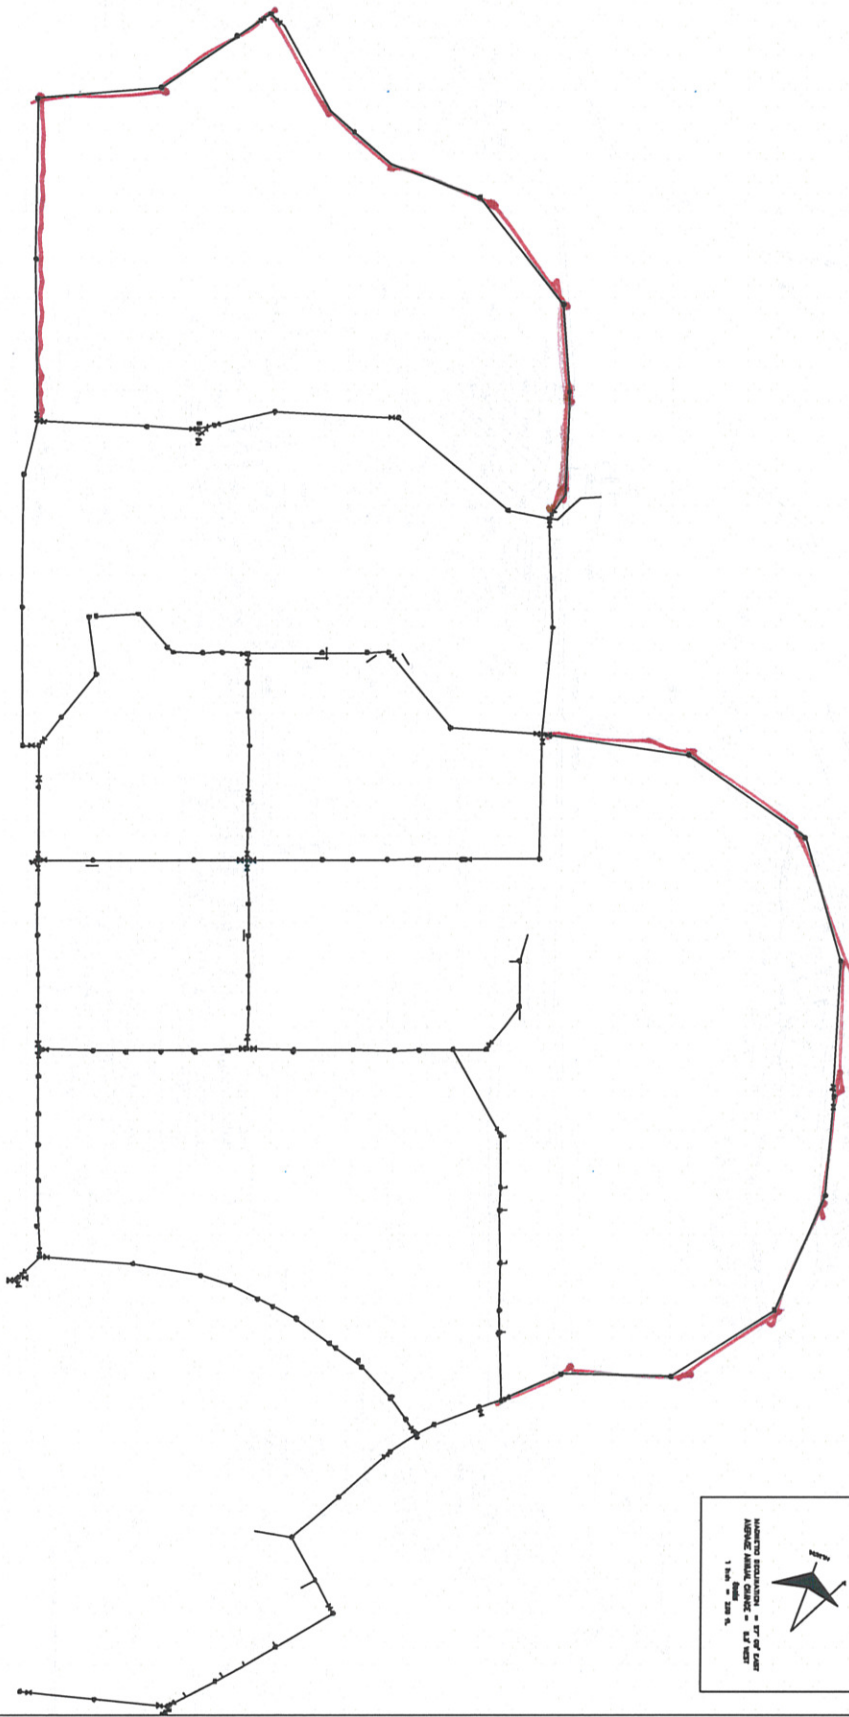
Following page (Red Color Code): This map provides a single line depiction of the UTILIDOR-ENCLOSED underground utility piping serving the 801-lease areas. The utilidor enclosed piping systems include steam supply & condensate return, drinking water distribution, and wastewater collection piping.

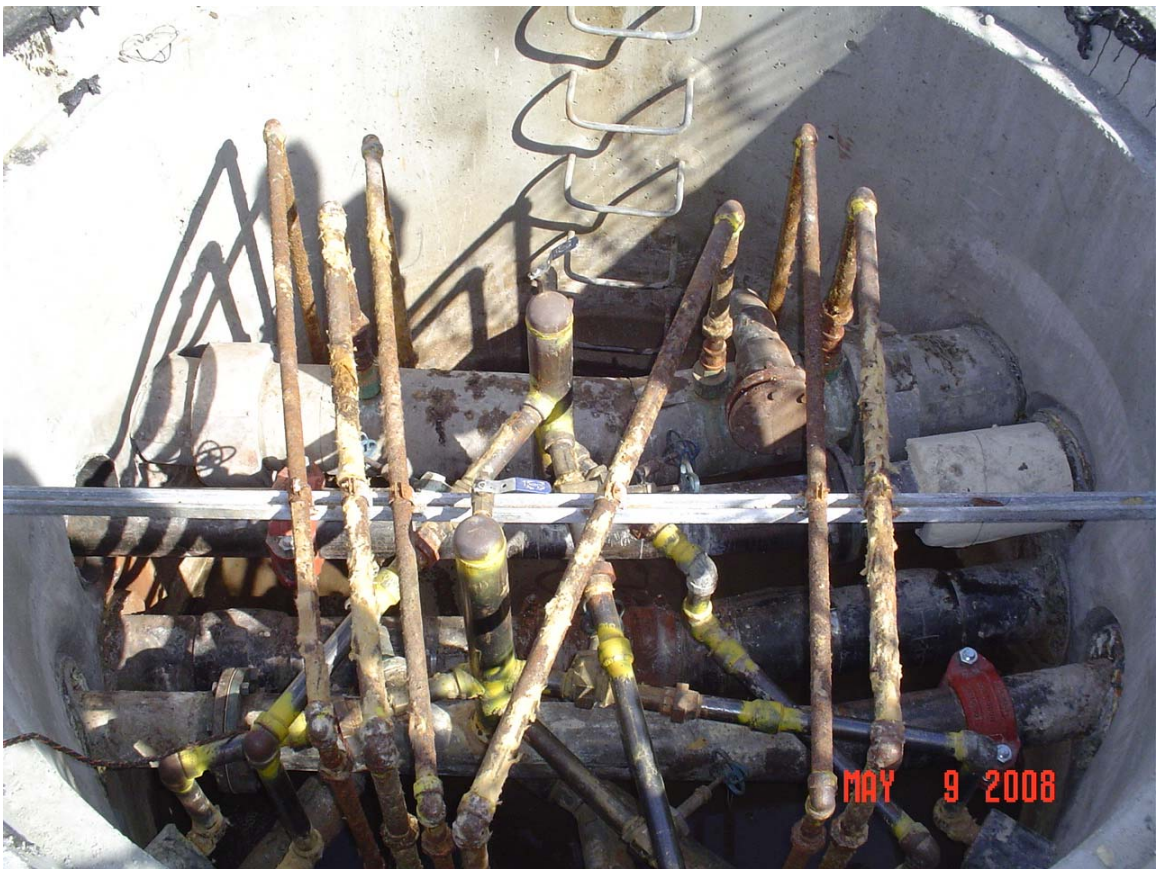
The picture below provides an example of the typical Point of Demarcation (POD) within the 801-lease areas' direct bury utility piping; the 'utility' (installation) retains the large diameter secondary distribution/supply/return/collection piping; the PO becomes responsible for the small diameter building/unit service laterals. Please note: some of these manholes are located >25ft from the building/unit served.

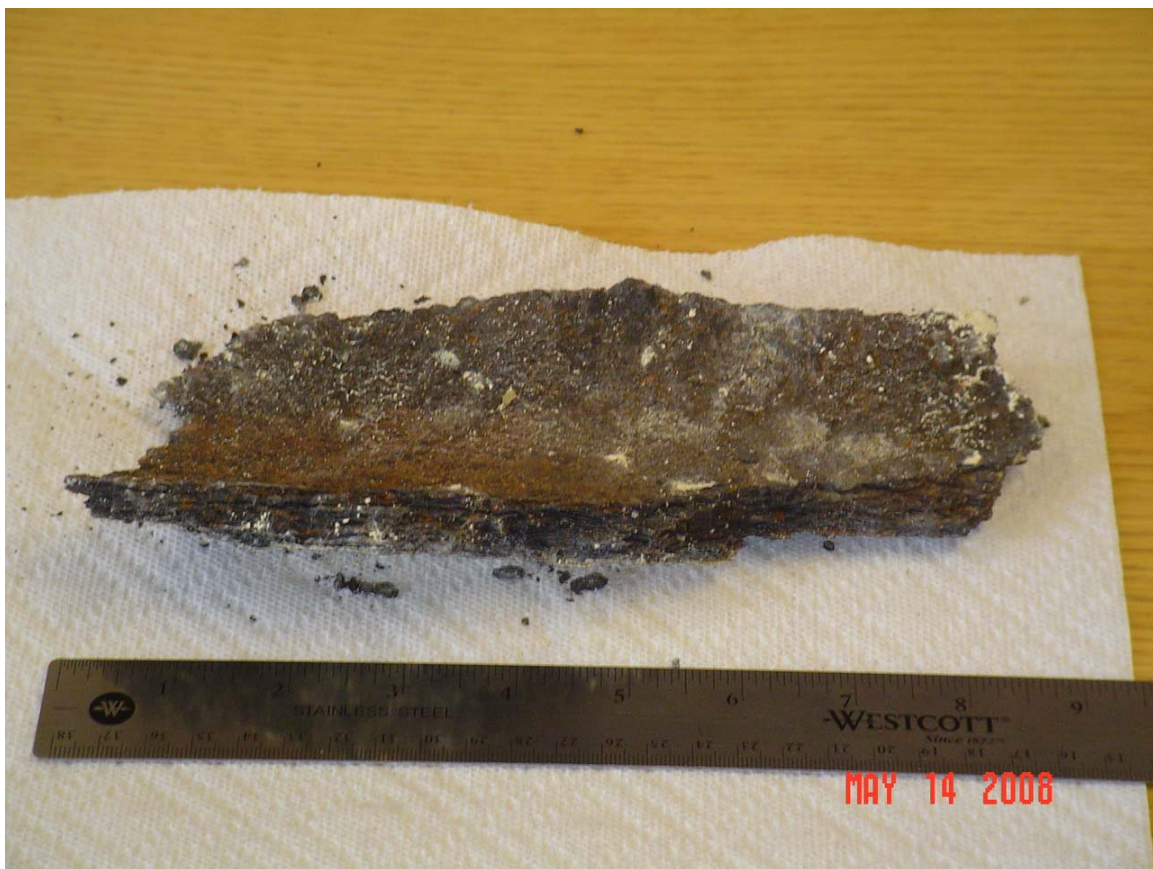
This picture provides an example of a delaminated, steel heat supply/return pipe; the MFH maintenance contractor repaired this pipe when it failed due to external corrosion. We suspect similar corrosion problems with the direct bury steel heat supply/return pipe in both the Moose Lake and French Creek neighborhoods.

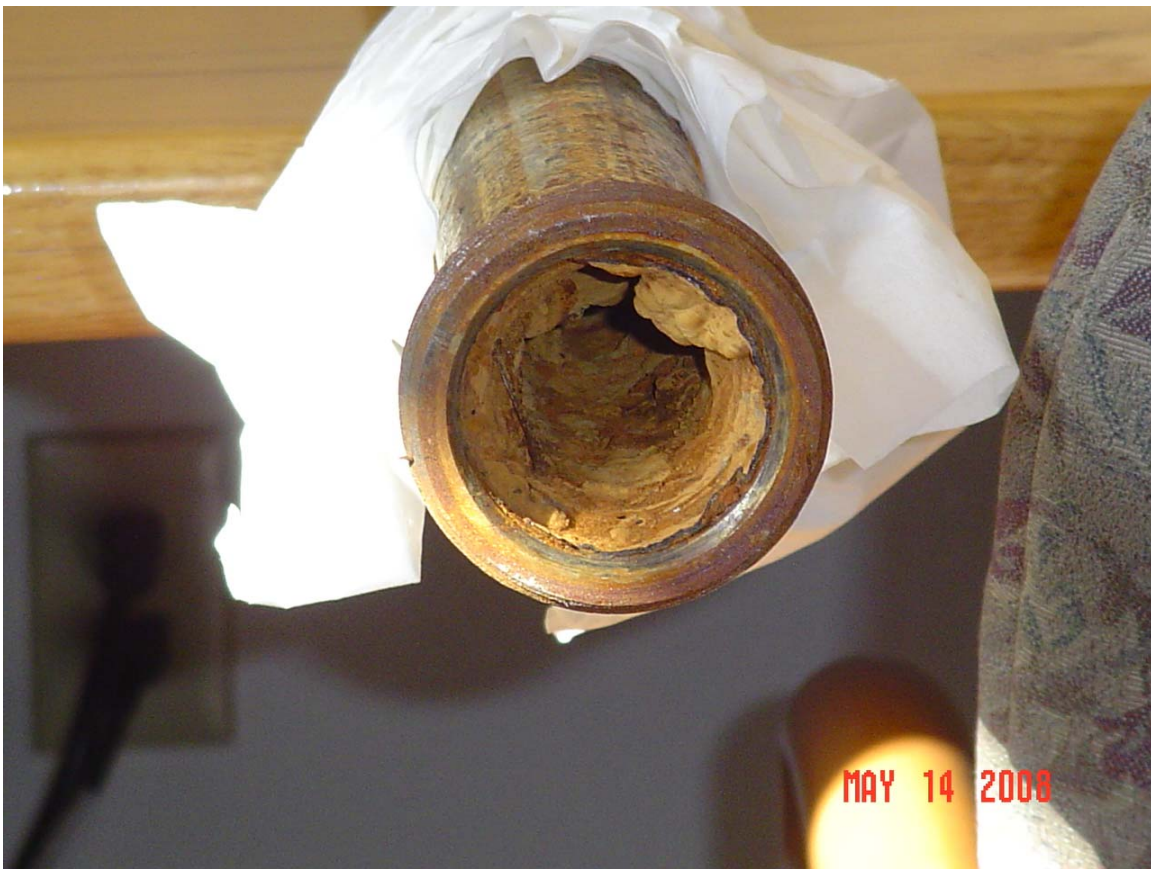
Shown below is an example of the excessive scale build-up in the steel heat supply/return pipe; due to leaks, we must add make-up water on a regular (constant) basis; the hardness & trace minerals in the make-up water drop out of solution when heated; excessive scale build-up presents several problematic issues--most notably: scale masks corrosion nodules, decreases pipe flow capacity, detrimentally impacts heat transfer.

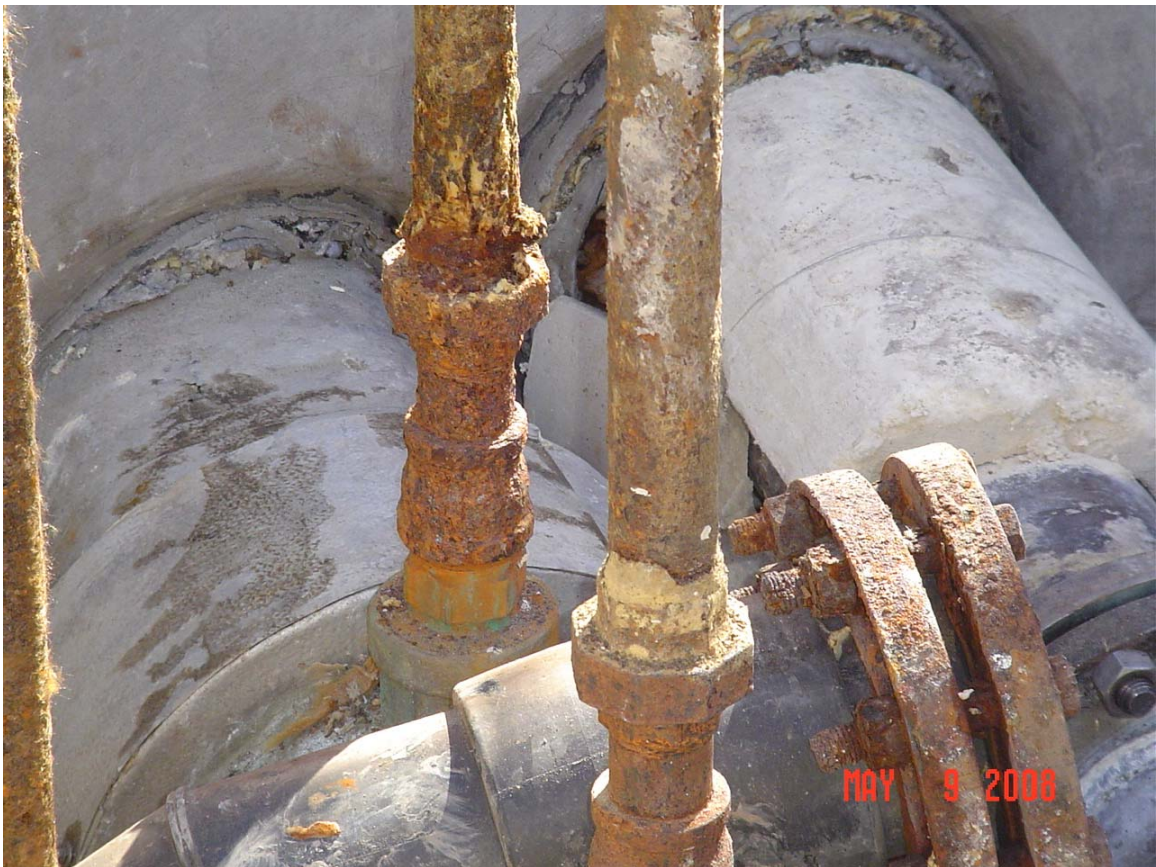
The picture below provides an example of external corrosion of small diameter building/unit service lateral pipes. Again, we suspect similar corrosion problems with small diameter service lateral piping in both the Moose Lake and French Creek neighborhoods.
